INDOOR AIR QUALITY ASSESSMENT

**Putnam Vocational Center
1300 State Street
Springfield, Massachusetts**

Prepared by:
Massachusetts Department of Public Health
Bureau of Environmental Health Assessment
September, 2000

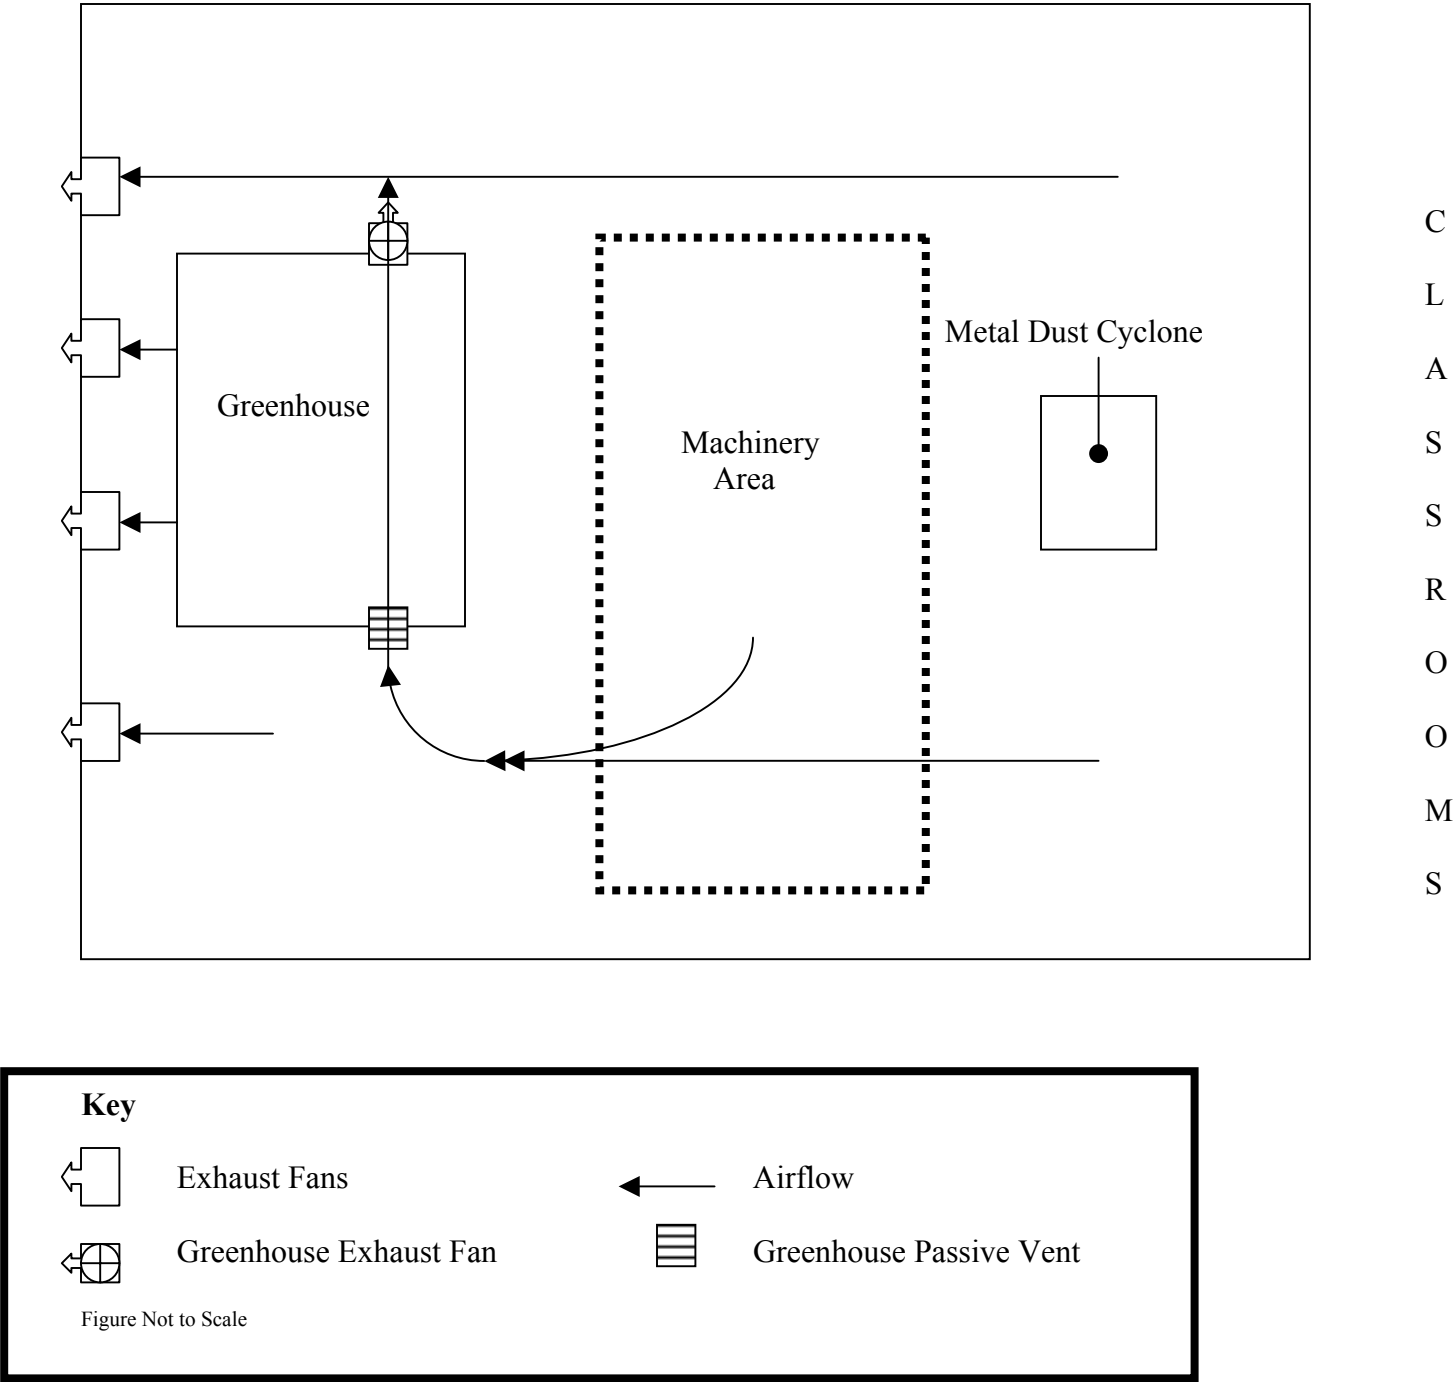
Figure 2

4. The position of the greenhouse would effectively block the existing exhaust vents in the west wall (see Figure 2) This condition can result in fine metal dust accumulating in the metal shop area.

Greenhouse Blocking Exhaust Vent Airflow

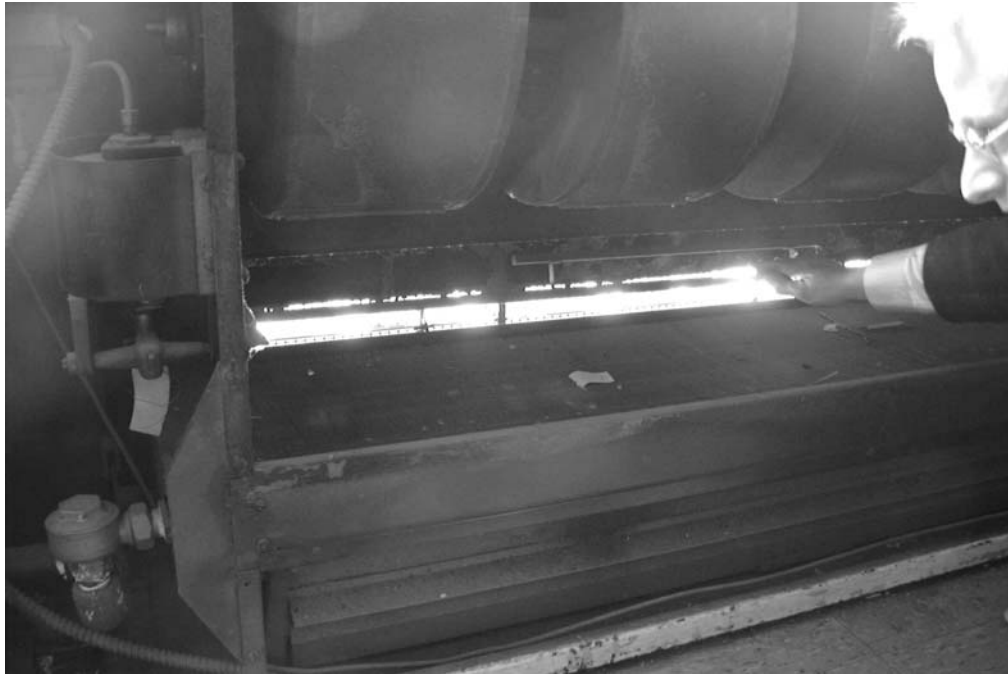
Picture 4

Interior of Vintage Univent in A-Wing, Note No Filters Were Installed In Unit

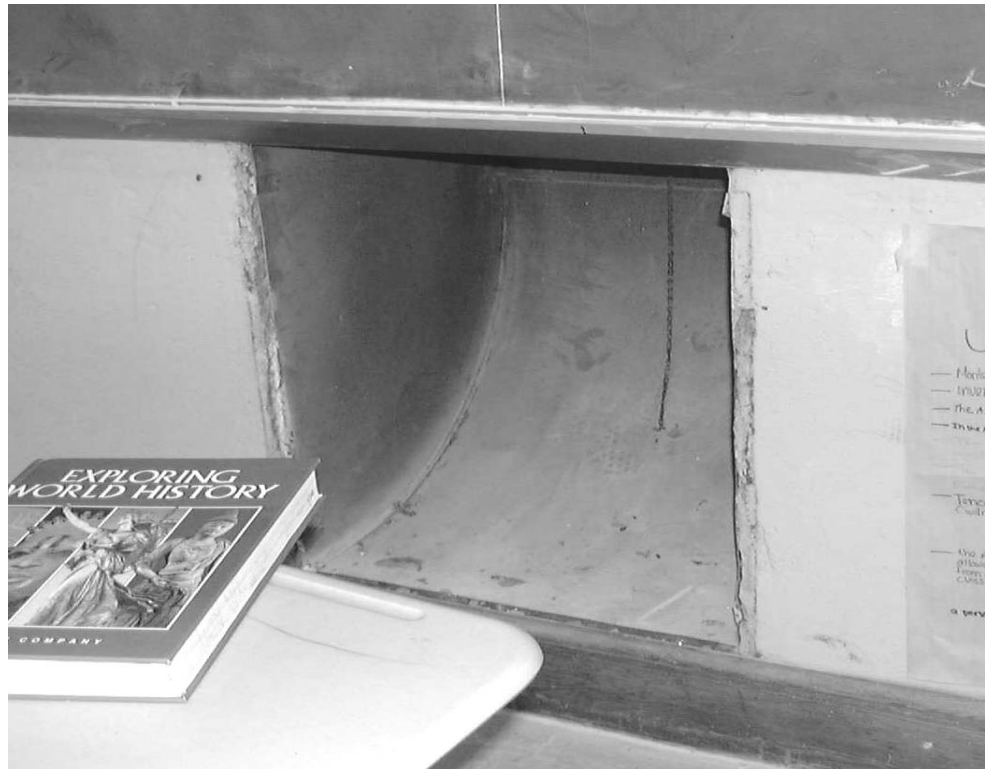
Picture 5

Exhaust ventilation in A-wing was originally provided by ducted natural/gravity feed vents. Airflow was controlled by louvers, which were opened/closed by a draw chain-pulley system (see Picture 5). The louvers could be set at a desired angle by setting the draw chain in a locking mechanism. It appears however, that the exhaust system has been abandoned. Exhaust vent louvers were closed/damaged in many classrooms, some vents were also missing grates and/or pull chains. Exhaust vents were not drawing air in many classrooms, and in some cases, were backdrafting (air coming out of the vent). An examination of the roof found likely termini of gravity vents missing or sealed with plywood.

Classroom Gravity Feed Exhaust Vent, Note Hanging Pull Chain to Adjust Exhaust Flue

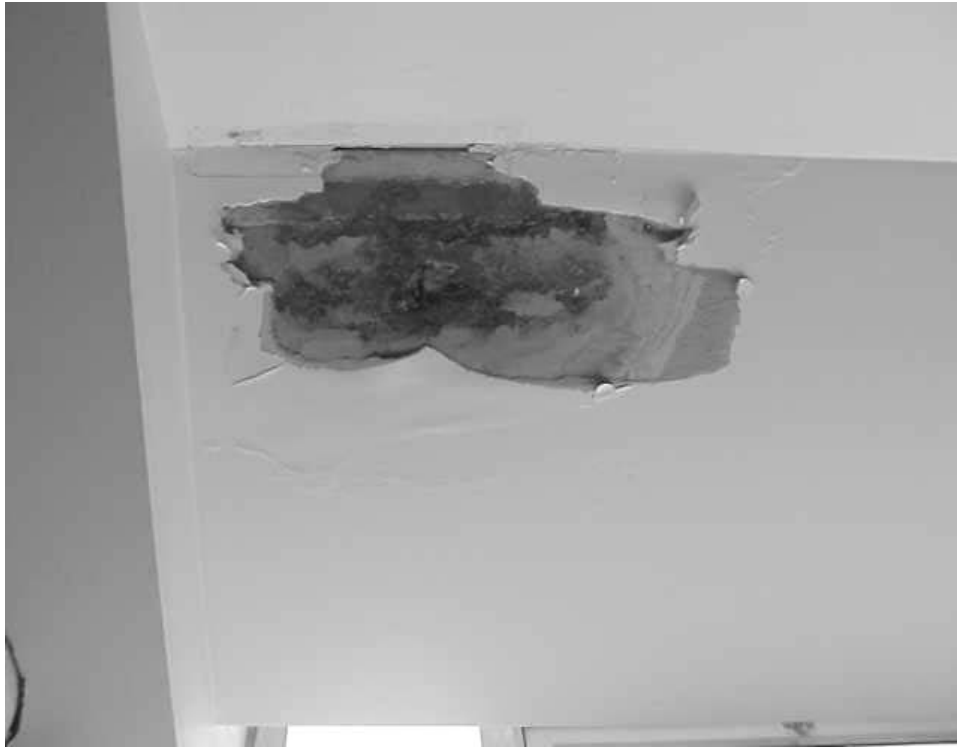
Picture 7

A number of interior areas of the building had signs of water damage. Water damaged wall/ceiling plaster was noted throughout the building (see Picture 7). Water damaged ceiling tiles were seen in a number of areas, which is evidence of historic roof or plumbing leaks. The women's locker room has water damaged ceiling plaster, which corresponds to the water damaged gymnasium floor beneath a water fountain (see Picture 8). Water damaged wood, plaster and ceiling tiles can serve as a mold growth medium, and should be replaced after a water leak is discovered. Possible mold growth was observed on ceiling tiles in the gym. The HVAC shop was noted by BEHA staff to have

Water Damaged Ceiling Plaster

27. Replace any remaining water-stained ceiling tiles. Examine the area above and around these areas for mold growth. Disinfect areas of water leaks with an appropriate antimicrobial.

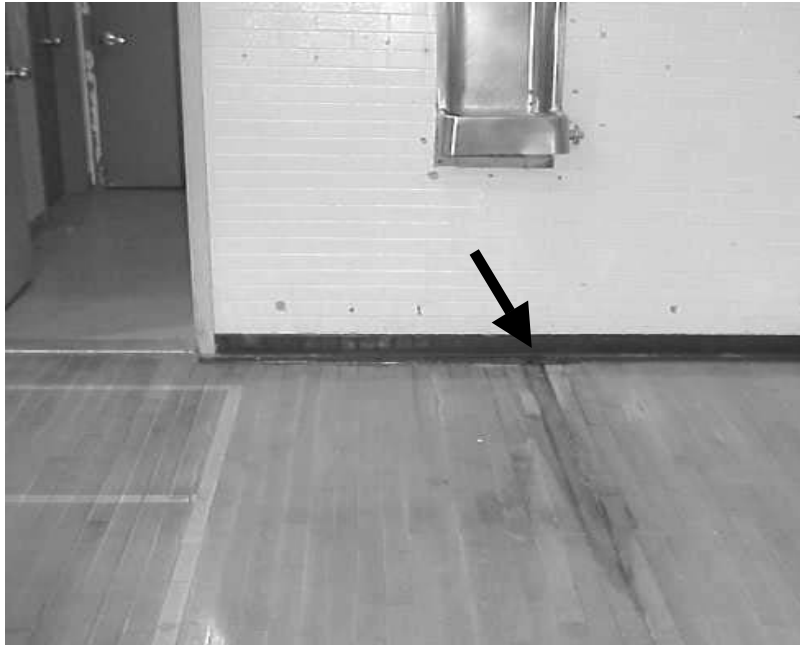
Picture 8

Water Damaged Gymnasium Floor

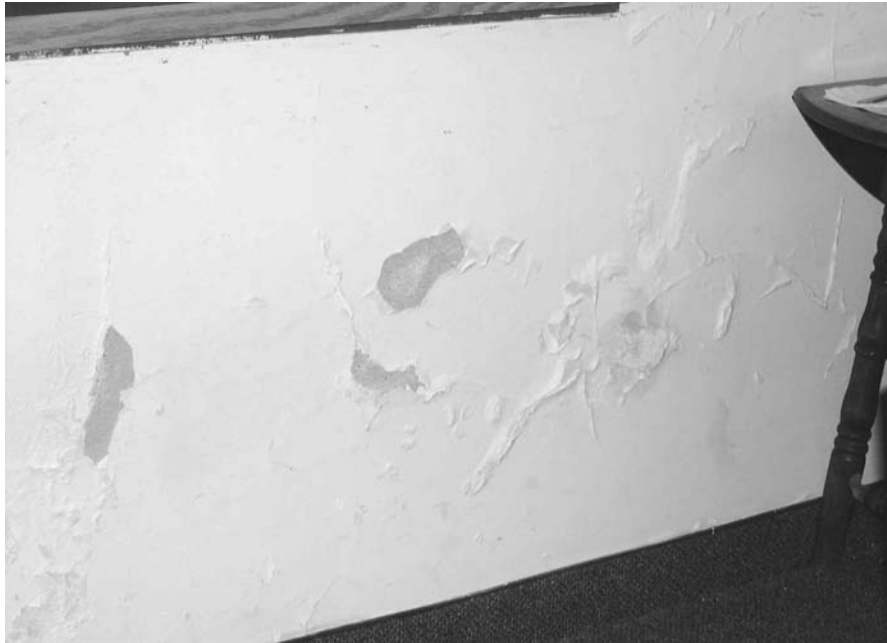
Picture 9

Water intrusion was evident by the presence of efflorescence (e.g., mineral deposits) on both interior and exterior brickwork (see Pictures 9 and 10). Efflorescence is a characteristic sign of water damage to brick and mortar, but it is not mold growth. As moisture penetrates and works its way through mortar around brick, water-soluble compounds in bricks and mortar dissolve, creating a solution. As this solution moves to the surface of the brick or mortar, the water evaporates, leaving behind white, powdery mineral deposits. Water damage was especially prevalent in the auditorium and locker rooms.

Water Damaged Wall Plaster Indicating Moisture Penetration

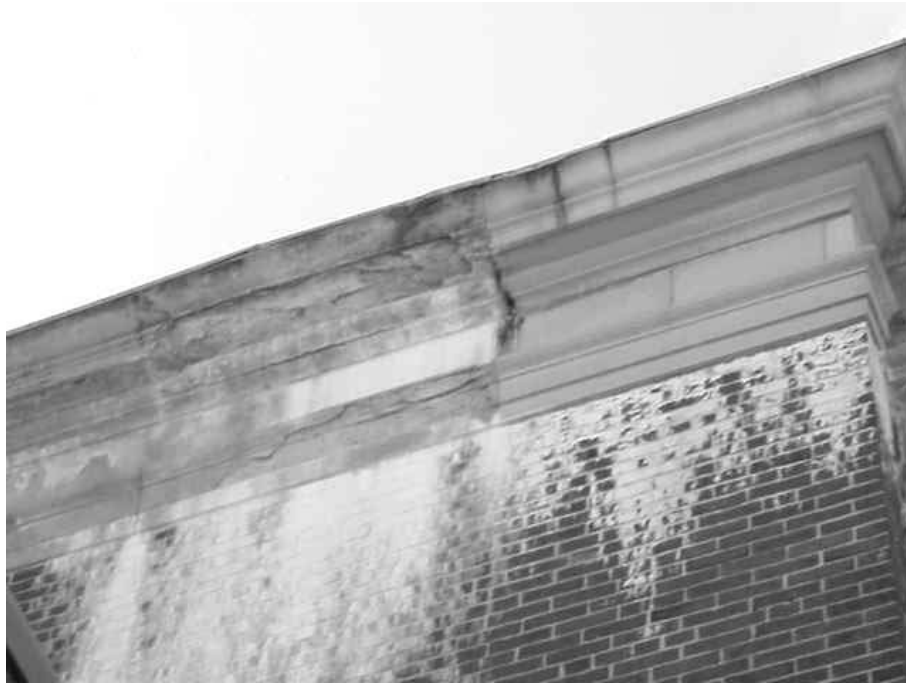
Picture 10

Efflorescence on Exterior Brickwork Indicating Moisture Penetration

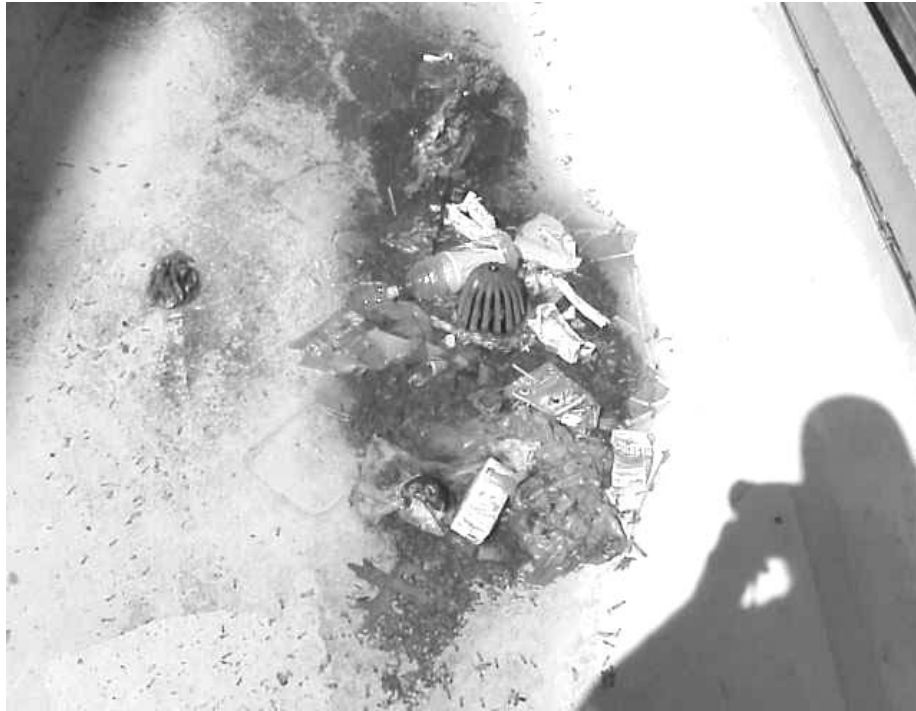
Picture 12

Accumulated Debris around Roof Drain Strainer

13. Remove leaves, trash and other accumulated wastes from school roofs.
14. Clean all low-lying roofs drain catches of debris to enhance rainwater drainage. Replace all missing drain catches to prevent drain clogs. Examine each roof drain for clogs and remove where found. Consider instituting a low lying roof inspection on a weekly basis to examine catch basins for blockage.

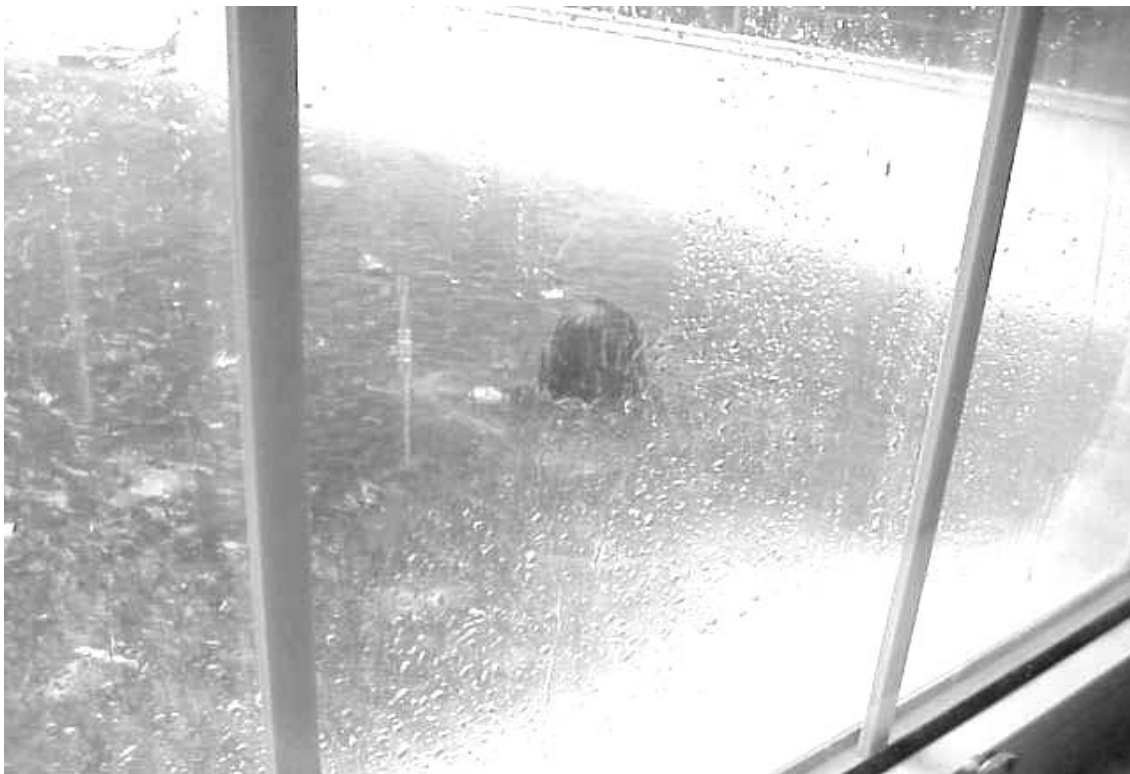
Picture 13

Water Pooling on Roof

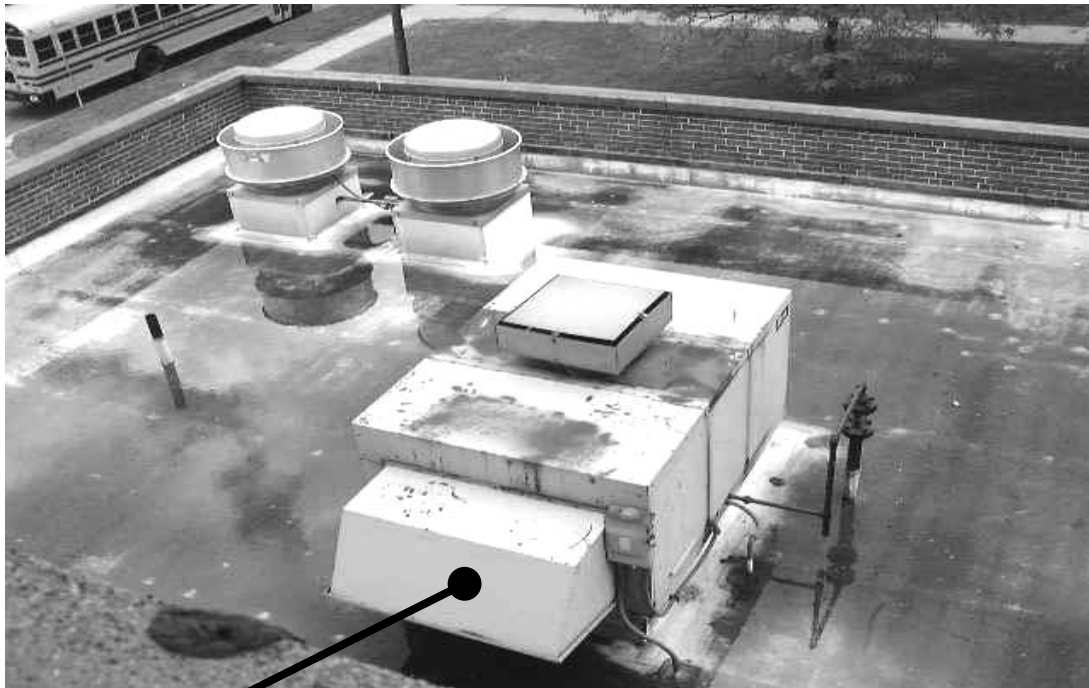
Picture 14

AHU Unit Surrounded by Pooling Water

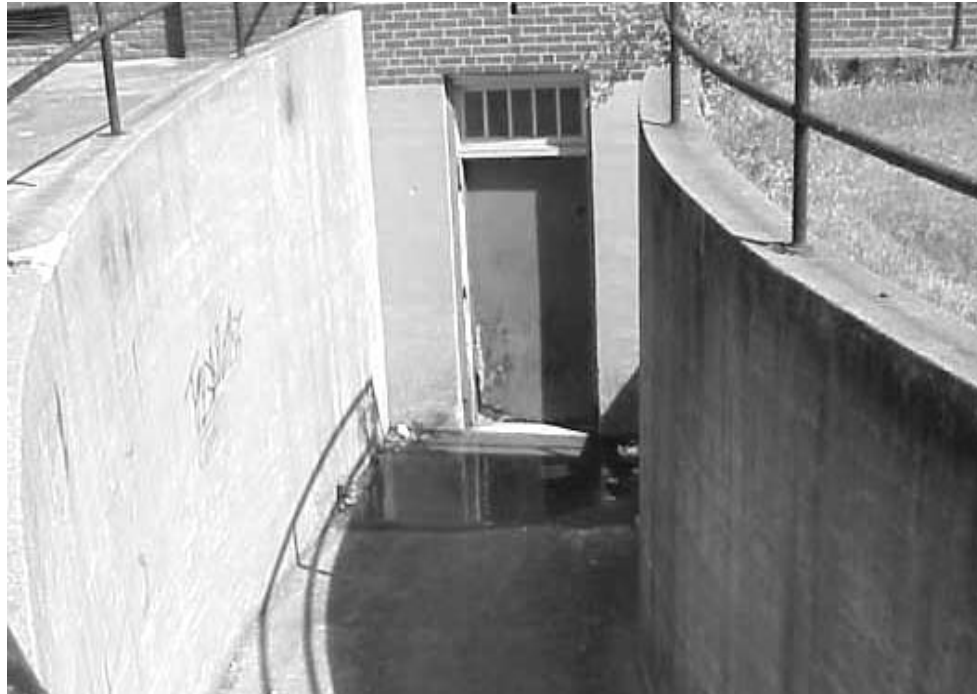
Picture 15

Water accumulation was also noted against the building in lower areas. As an example, several inches of water were seen at the bottom of a ramp leading into the basement storage area (see Picture 15). Although a drain was observed, water had collected in the area and had entered the basement under the door. The door in this area showed signs of repeated water damage. Pooling water was also noted in the first floor men's restroom near B-100.

Water Accumulation at Bottom of Ramp, Note Water Damaged Wooden Door

30. Examine basement storage area for proper drainage and make repairs as needed, examine periodically for standing water.
31. Examine water-stained carpeting in the main office for mold growth. If moldy discard carpet. Disinfect areas beneath and around carpeting with an appropriate antimicrobial.

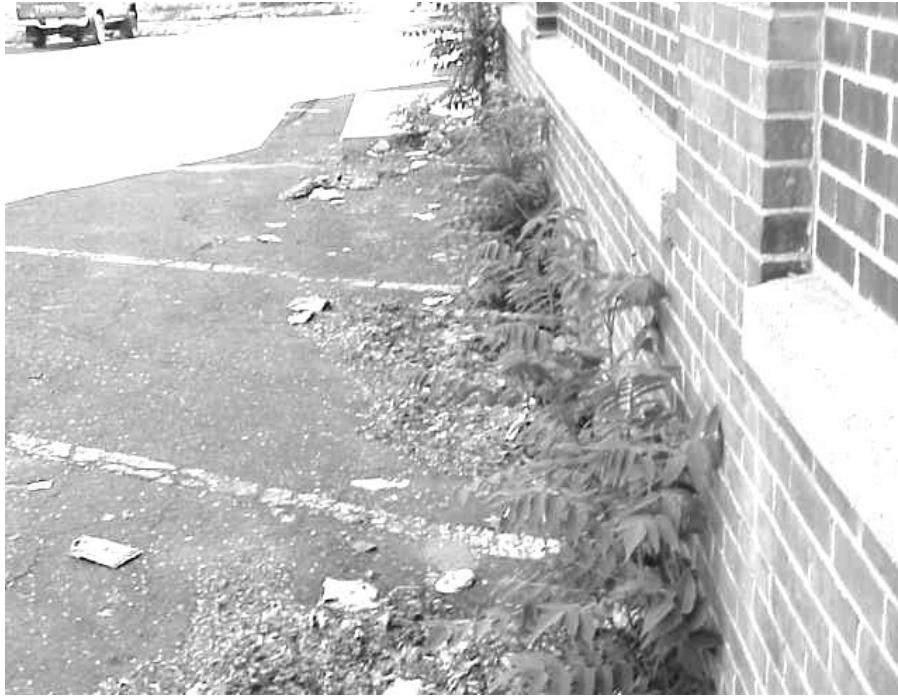
Picture 16

Opportunity for water penetration through the building envelope exists along the exterior wall/tarmac junction. Plants were noted growing in this area (see Picture 16). Water can gather in the wall/tarmac seam. Freezing and thawing of gathered water can result in damage to the exterior wall, which can lead to in water penetration into the building.

Plants Growing in the Exterior Wall/Tarmac Junction

20. Remove all vegetation from the exterior wall/tarmac seam. Reseal tarmac cracks. Seal the exterior wall/tarmac junction with a water impermeable sealant.

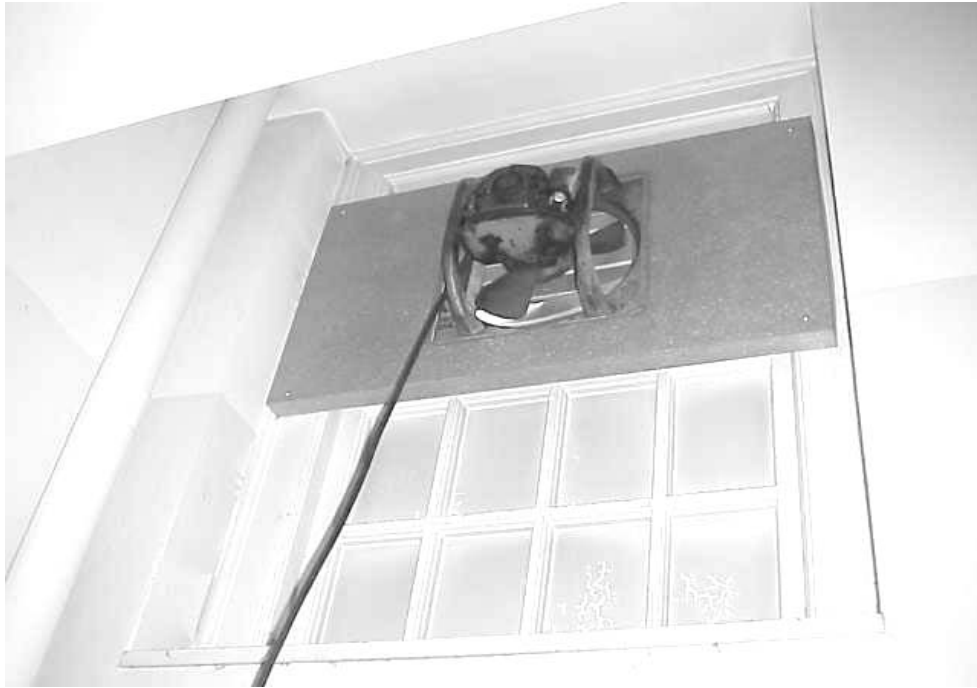
Picture 17

Inoperative Exhaust Fan in Kitchen Office

6. Repair restroom exhaust ventilation.
7. Repair the exhaust vent in the kitchen office.
8. Thermostat settings throughout the complex should be evaluated. Thermostats should be set at temperatures to maintain comfort for building occupants.

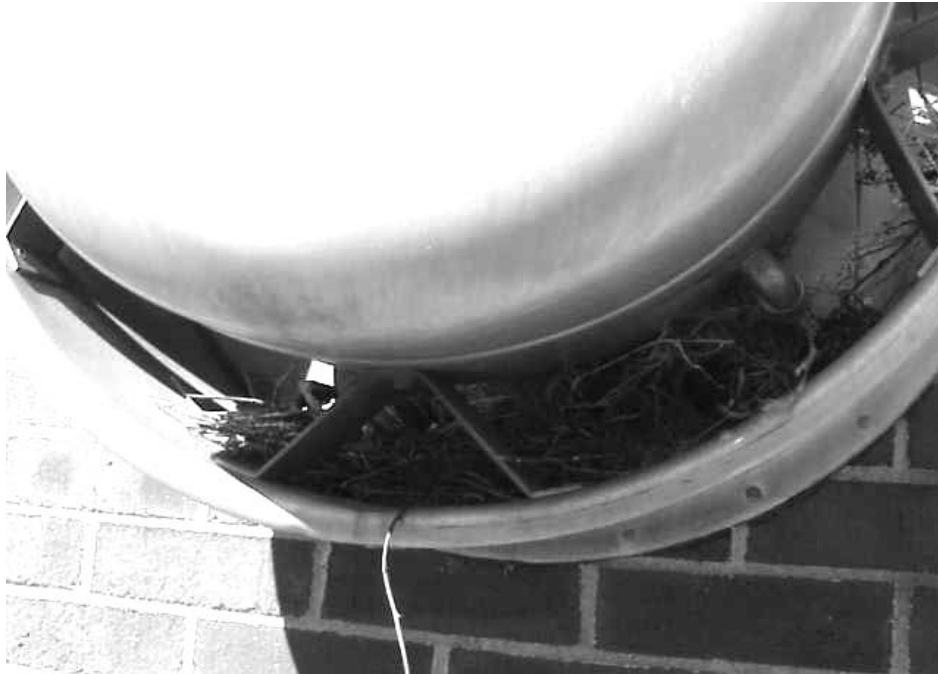
Picture 18

Damaged Metal Shop Exhaust Vent, Note Nesting Materials

21. Remove bird's nests from the exhaust vents of the metal/horticultural shop. Repairs these exhaust fans to working order. Examine the feasibility of installing fans in a configuration to reduce vandalism of this equipment.

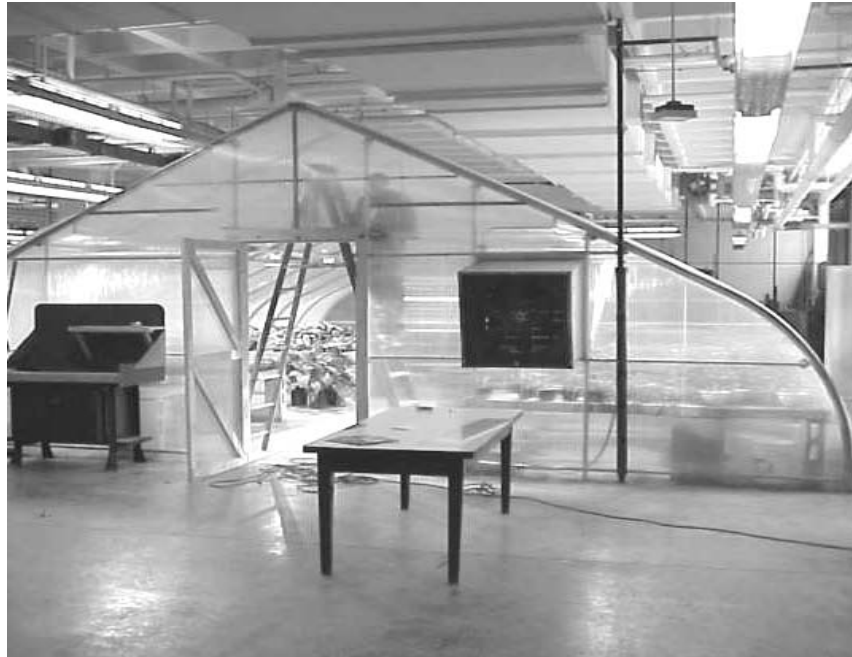
Picture 19

area (see Picture 19), since the school could not obtain permits from the Springfield Building Department. The greenhouse has a single exhaust vent fan located in its north wall to exhaust air and excess moisture. The south wall of the greenhouse has a passive vent that would allow outdoor air to enter the greenhouse. This configuration of the greenhouse in the metal shop poses several problems.

Greenhouse Erected inside of Metal Shop

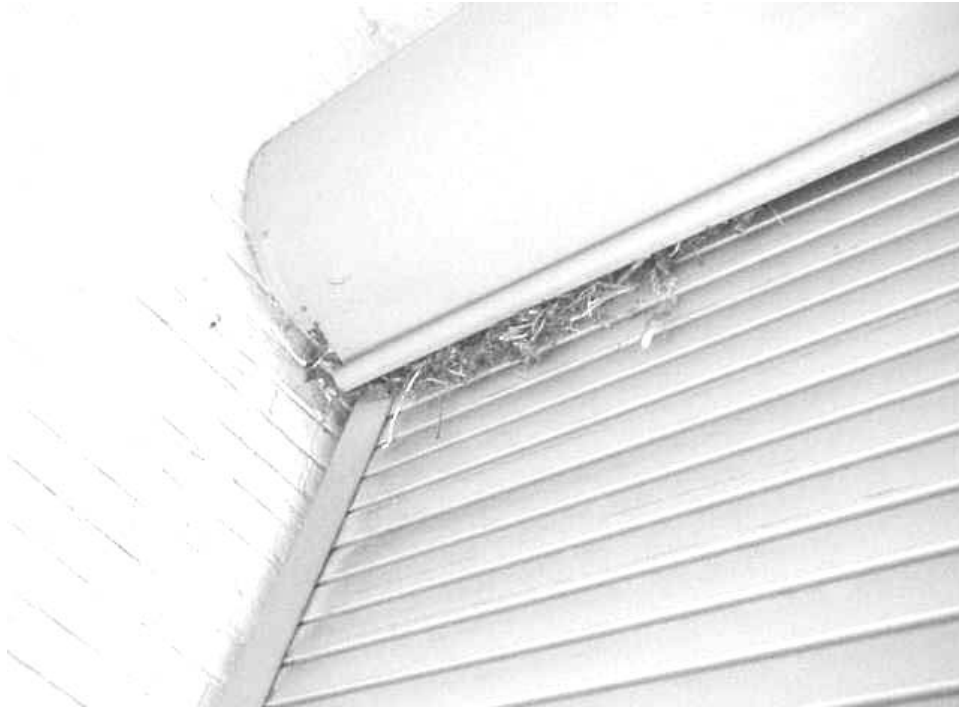
Picture 22

Bird nest in the Roll Up Door of the Graphics Department

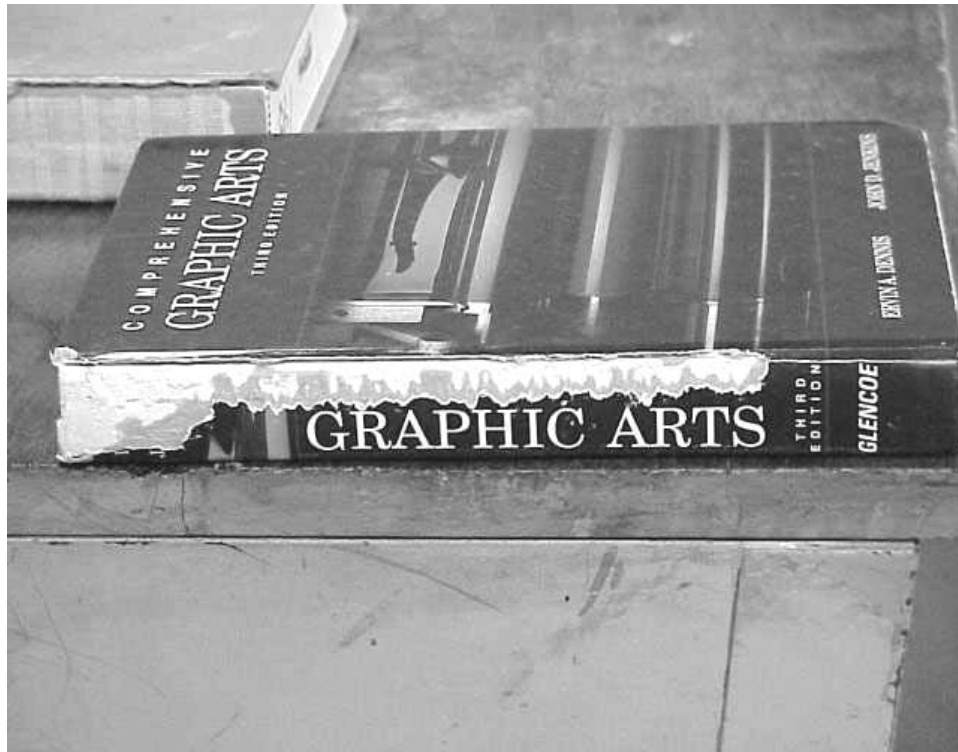
Picture 23

The building also shows signs of rodent infestation. It was reported to BEHA staff that mice had been seen in the building and mouse wastes were found in refrigerator drip pans. Rodents were also reported to have eaten the bindings of textbooks (see Picture 23). An examination of the exterior of the building identified several rodent harborages. Yard waste (see Picture 24), dirt piles (see Picture 25) and other collections of debris can provide adequate shelter to support rodent populations. To penetrate the exterior of a buildings, rodents require a minimal breach of ¼ inch (MDFA, 1996). Spaces beneath doors and holes in wood panels (see Picture 26) were noted around the exterior of the building, each of which would be sufficient to allow rodents to enter the building. Rodent infestation results from easy access to food and water in a building. Evidence of food sources includes candy wrappers in univents and food on radiators in the cafeteria (see Picture 27). Rodent infestation can result in indoor air quality related symptoms due to materials in their wastes. Mouse urine contains a protein that is a known sensitizer (US EPA, 1992). A three-step approach is necessary to eliminate rodent infestation:

Book Binding in Graphics Department Eaten by Rodents

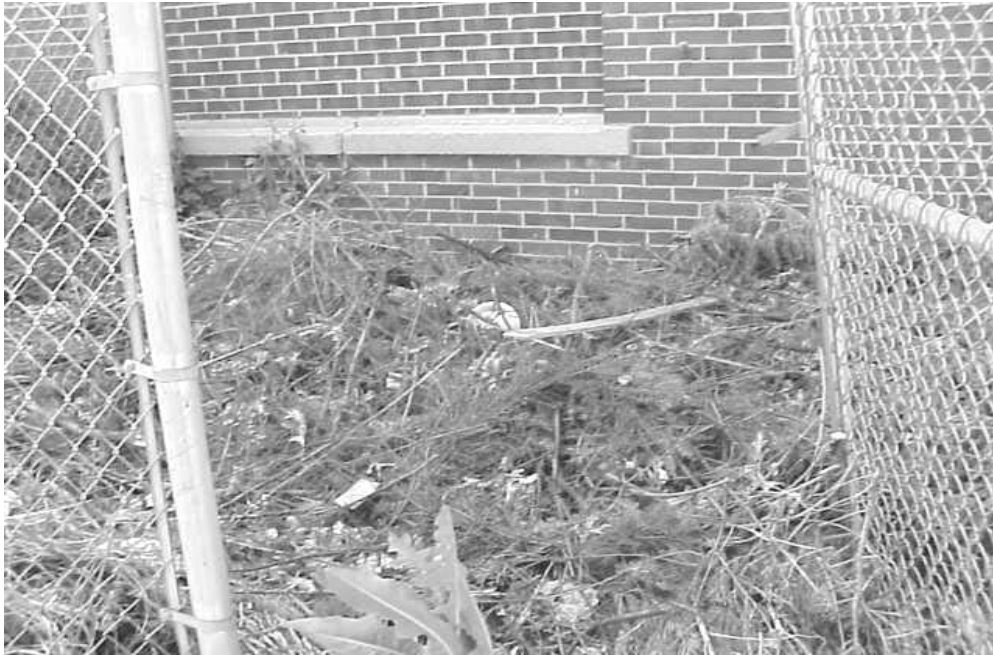
Picture 24

Yard Waste along Exterior Wall of Building

25. Remove accumulated yard waste and dirt piles along the exterior of the building to eliminate rodent harborages. Examine exterior wall for holes and reseal to prevent rodent access to the interior of the building. Examine all exterior door for spaces large enough to admit rodents. If found, consider sealing the bottom of each door with a barrier (e.g. weather stripping) to eliminate egress.

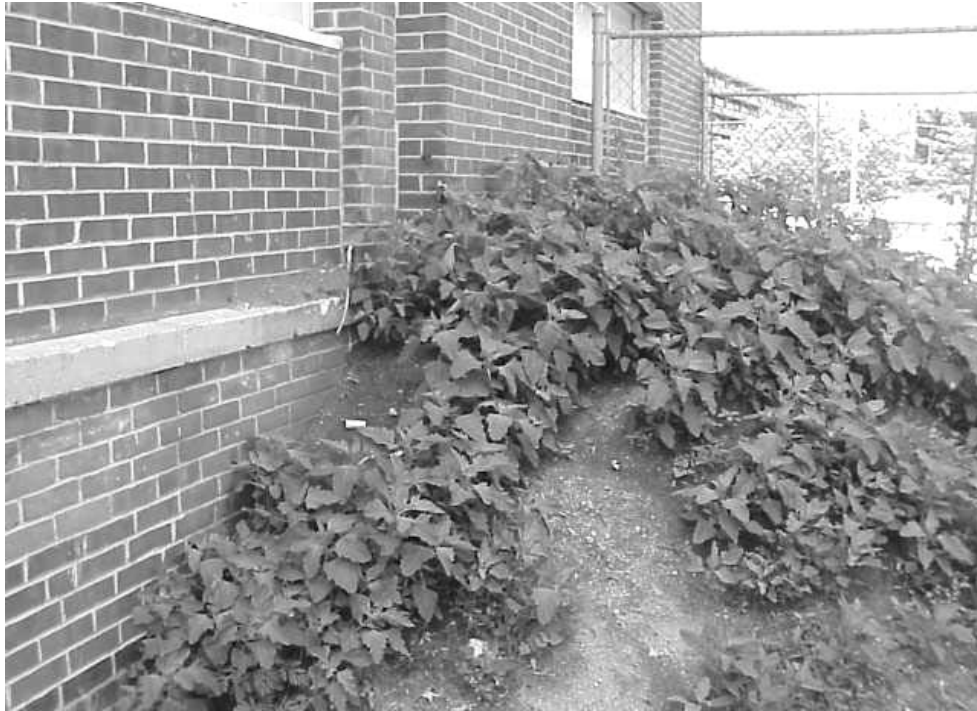
Picture 25

Dirt Pile along Exterior Wall of Building

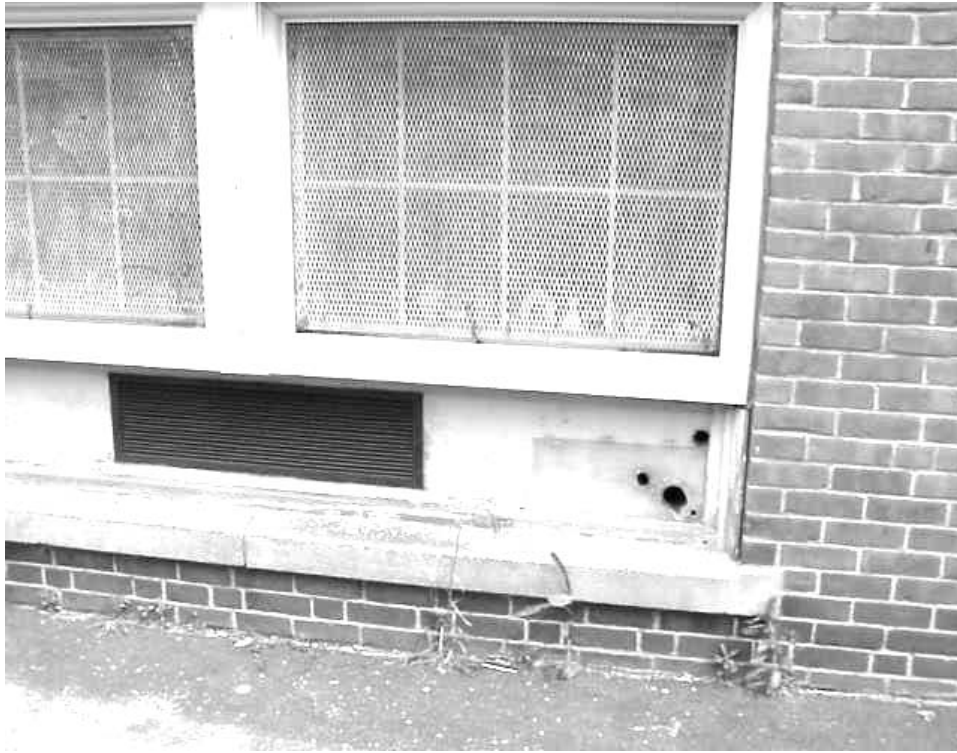
Picture 26

Hole in Exterior Panel at Base of Building

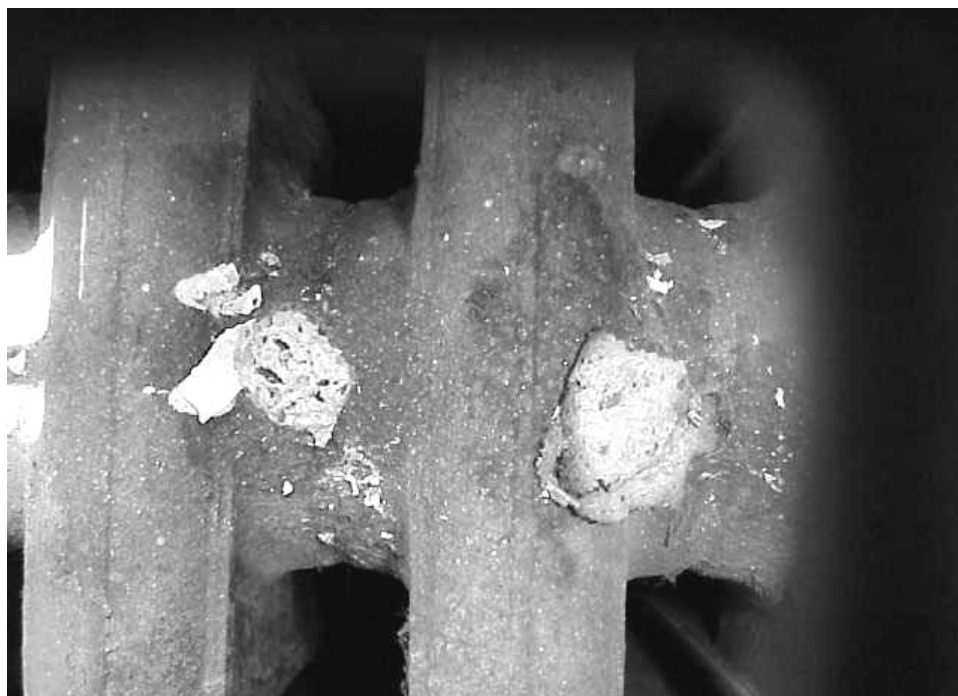
Picture 27

Food on Radiator in Cafeteria

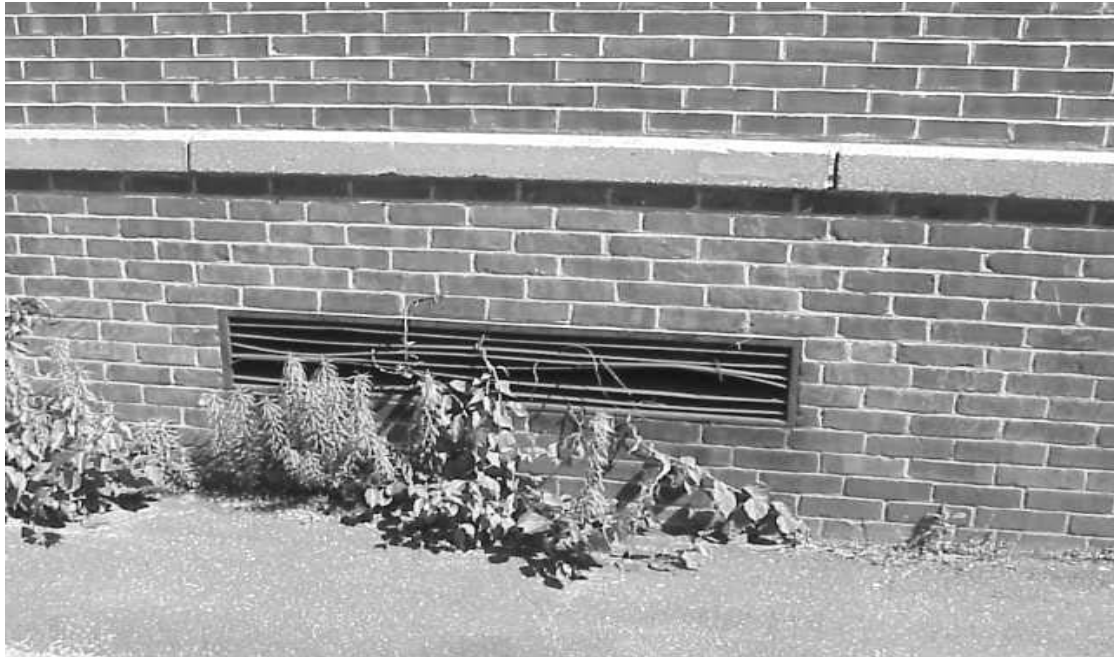
Picture 28

Along the perimeter of the building (and interior courtyard), univent fresh air intakes were noted close to ground level (see Picture 28). Care should be taken to ensure that fresh air intakes remain clear of obstructions (e.g., snow, shrubbery, etc.) to avoid the entrainment of dirt, moisture, pollen and/or other particulate matter.

Plants growing in Front of Univent Fresh Air Intake

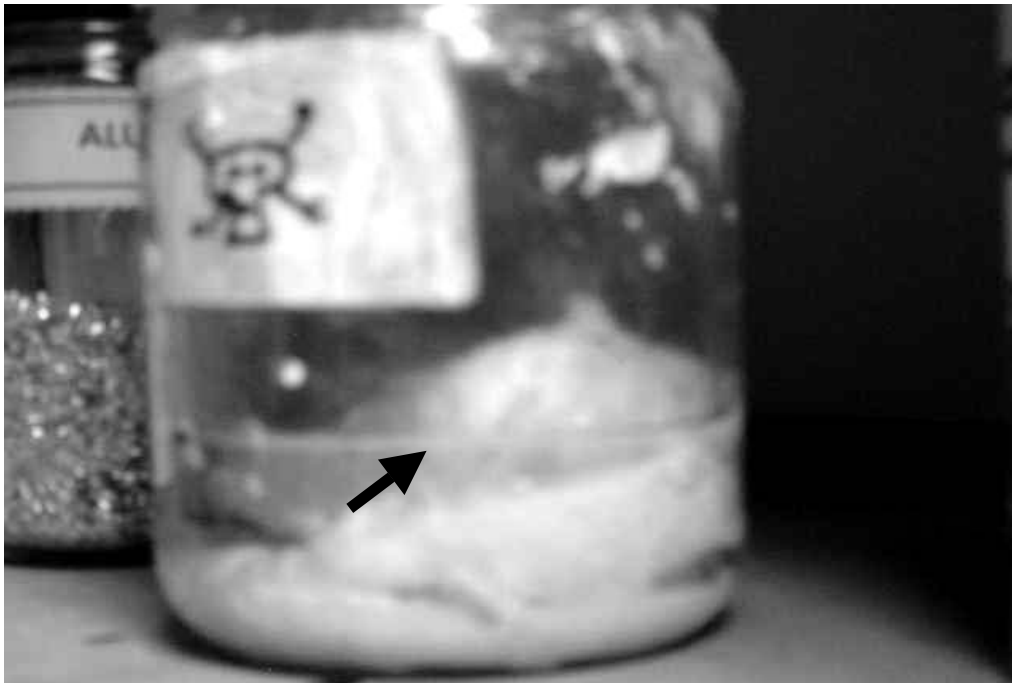
Picture 29

Chemicals were stored in a storeroom on the second floor science area of E-wing. Of note was the condition of a jar of sodium metal found stored on an open shelf in this area. Sodium metal is water reactive (NFPA, 1991) and is an extreme fire hazard. This material must be stored in a non-water liquid to prevent moist air from contacting the surface of this material. The liquid in the jar appeared to have evaporated exposing the upper surface of the material (see Picture 29). The conditions of the container can lead to the eventual drying of the storage liquid and exposure of sodium to the air, which is unacceptable for this material. It is highly recommended that a thorough inventory of chemicals in the science department be done to assess chemical storage and disposal in an appropriate manner consistent with Massachusetts hazardous waste laws.

**Container of Sodium Metal in Chemical Storage Area (E-Wing)
Note Exposed Sodium Metal above Liquid Line**

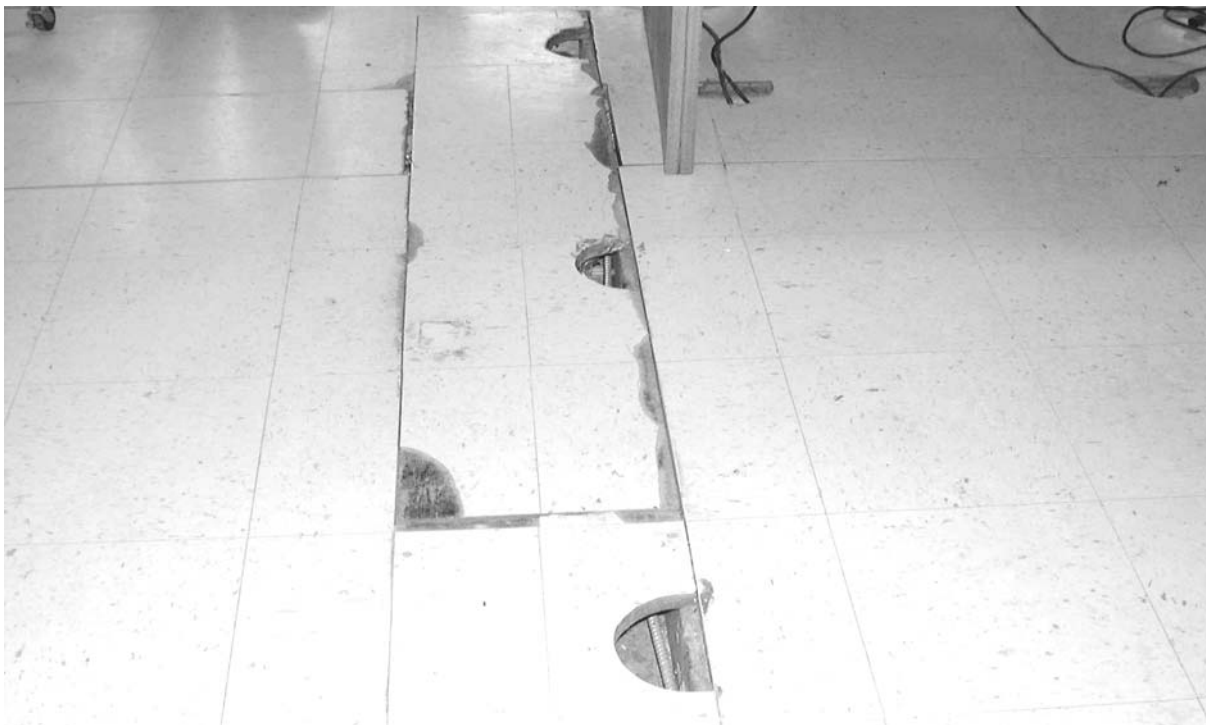
Picture 30

Concerns were raised by building occupants about the presence of asbestos in floor tiles in computer room A-304. Holes were bored in flooring to allow for wiring of equipment (see Picture 30). Possible asbestos containing floor tiles were also noted above the print shop/graphics area broken, damaged and crumbling (see Picture 31).

Holes in Floor Tile in Computer Room A-304

34. Examine asbestos floor tiles for damage. If asbestos is in a friable state, remove the damaged material in a manner consistent with Massachusetts asbestos remediation and hazardous waste disposal laws.

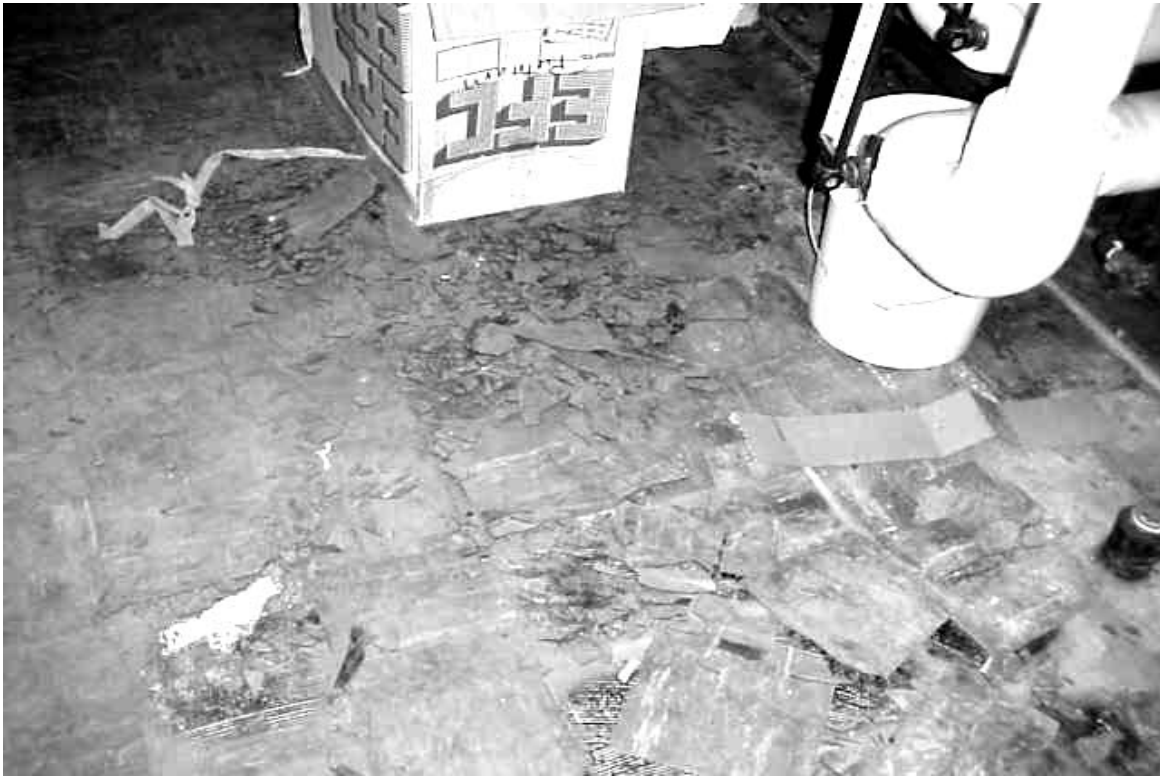
Picture 31

Damaged/Broken Floor Tiles in Room above Print Shop/Graphics Area

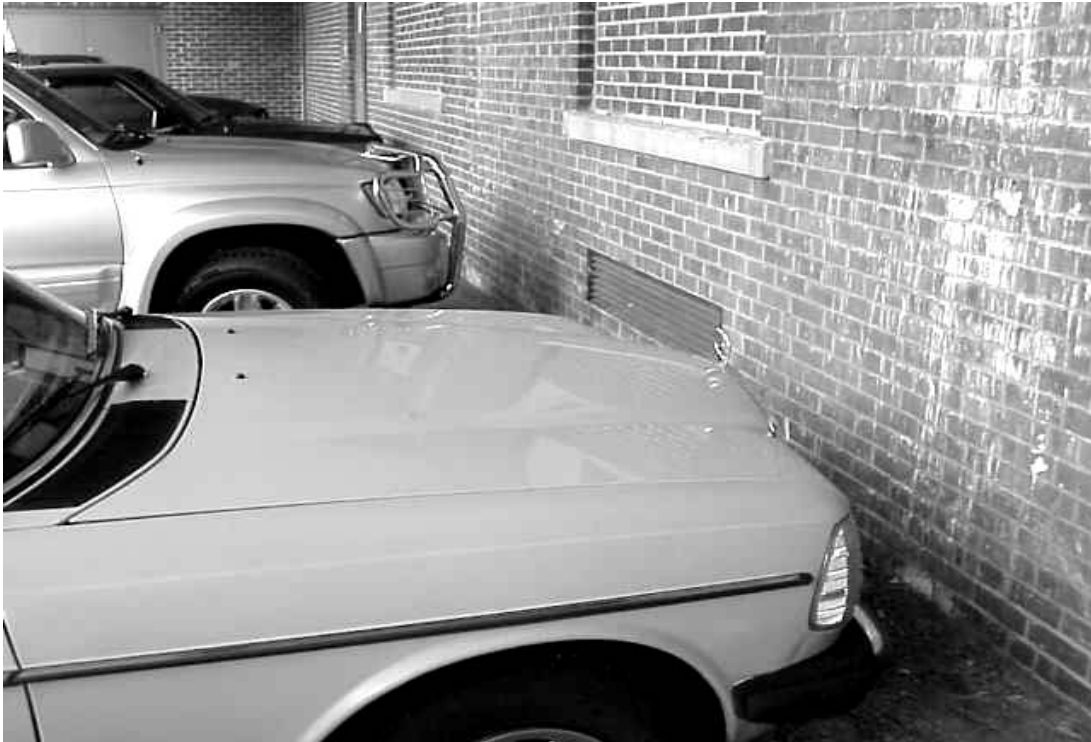
Picture 32

Vehicles Parked in Close Proximity to Univent Fresh Air Intakes
